Docket No. 217 – Development and Management Plan Inspection

Northeast Utilities Service Company Certificate of Environmental Compatibility and Public Need for the construction of a 345-kV electric transmission line and reconstruction of an existing 115-kV electric transmission line between Connecticut Light and Power Company's Plumtree Substation in Bethel, through the towns of Redding, Weston, and Wilton, and to the Norwalk Substation in Norwalk, Connecticut.

Date: December 1, 2005

Location: Overhead Line (Composite 345kV and 115kV Gallows Hill to Archers Lane)

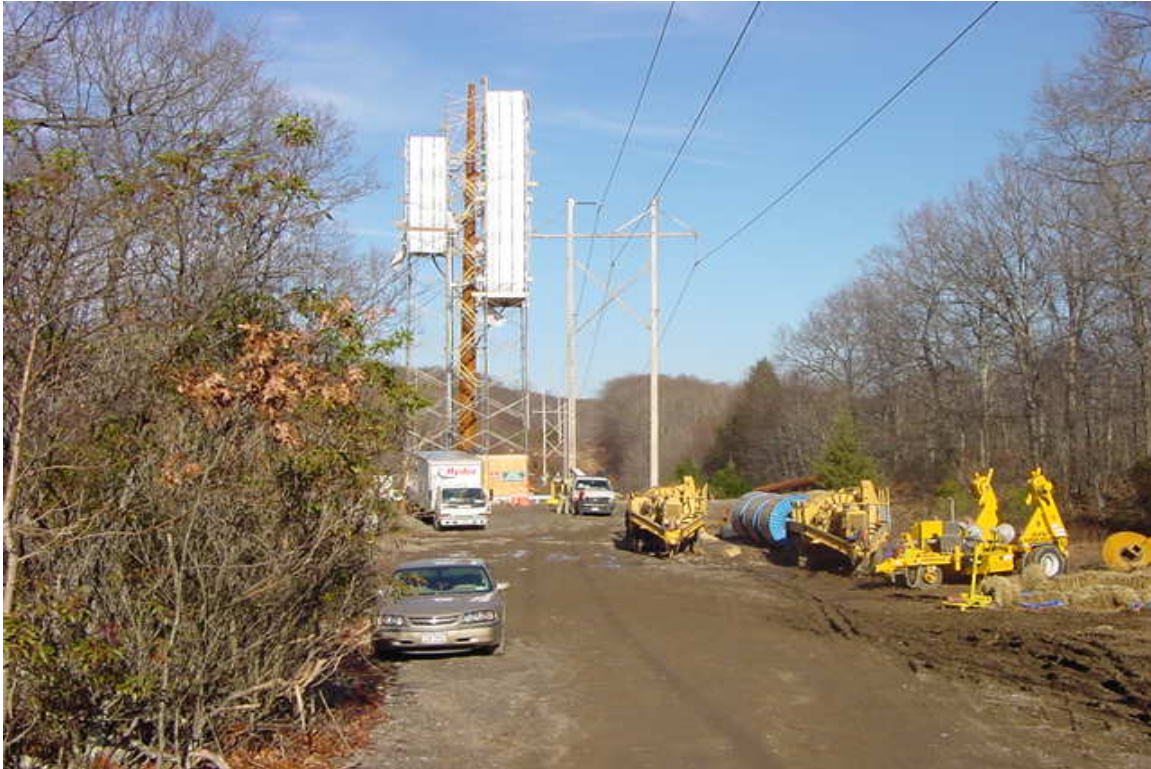
View of the structure off Gallows Hill where risers are being installed and the structure prepared for line work. 12/01/05

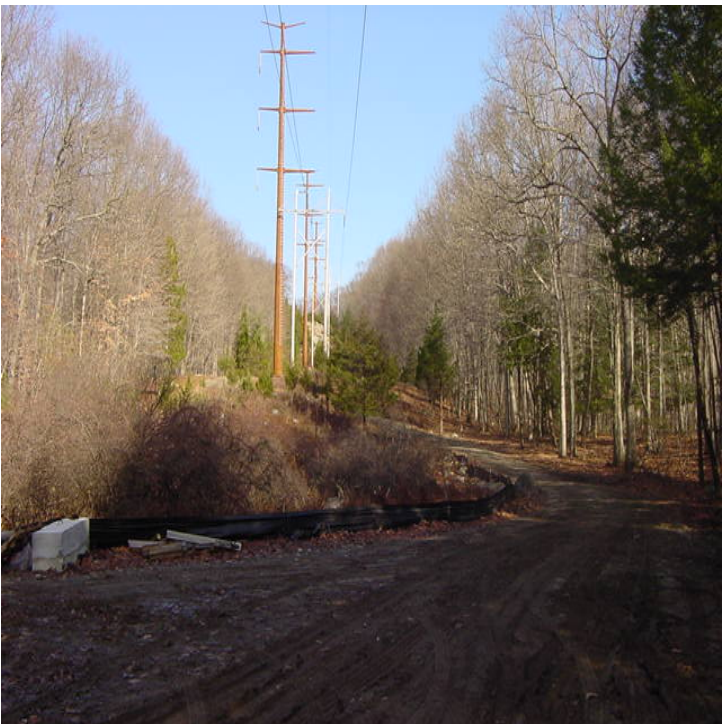
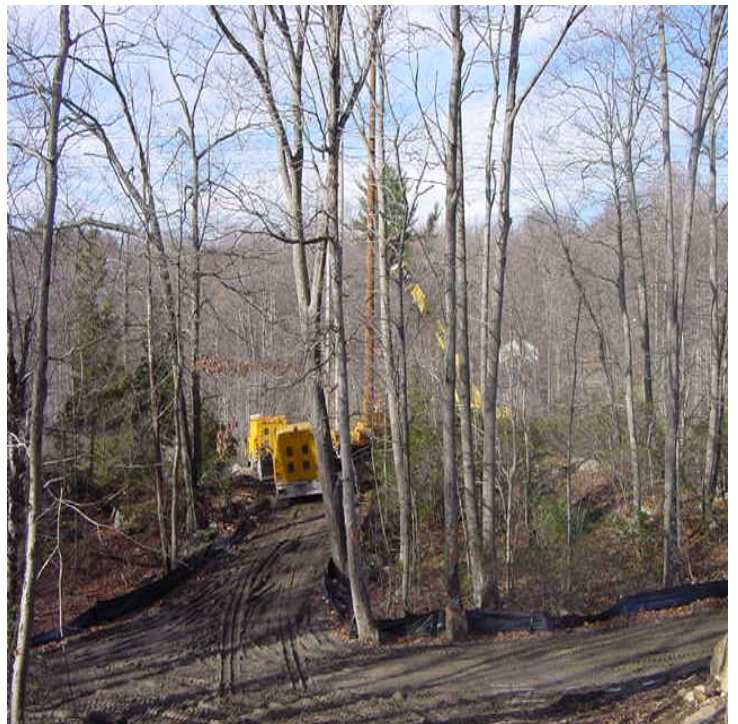
Photo on the left is looking along the ROW where the majority of poles have been installed. Photo on the right shows the installation of the structure located across from the transition station, at the beginning of the Archers Lane portion of the ROW. 12/01/05

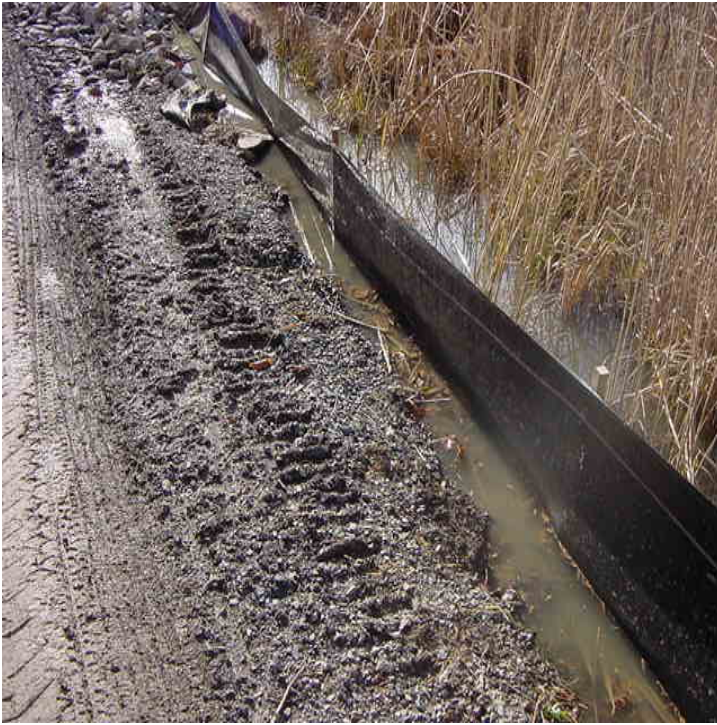
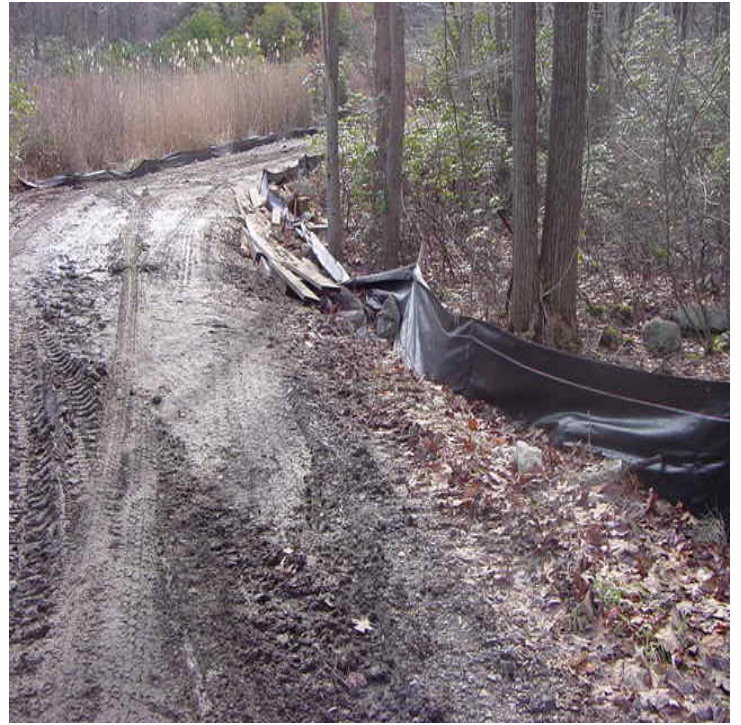
Photo on the left shows one of the wetland crossings along the access road where pooled turbid water is appears to be flowing underneath or around the fence to the wetland beyond. Photo on the right shows silt fence in need of repair at that same crossing. 12/01/050

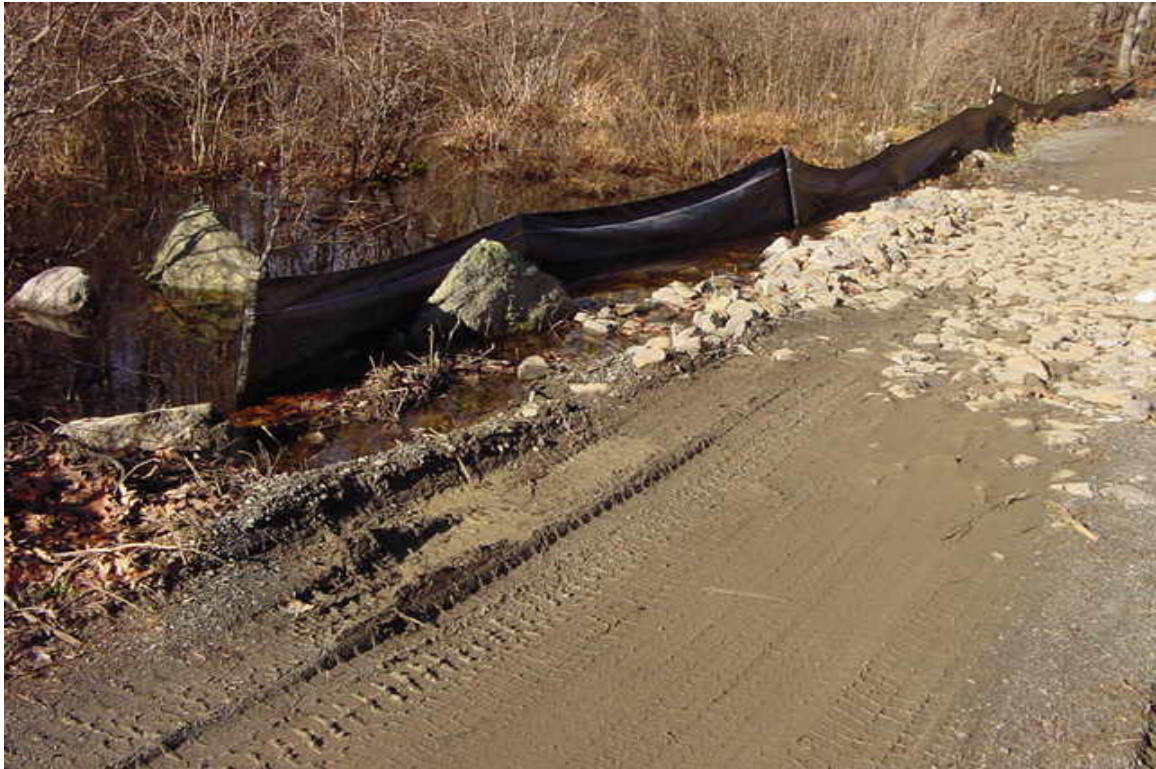
View of another wetland crossing where pooled water extends beyond the limits of the silt fence but remains clear at this point. Fence should still be extended. (12/01/05)

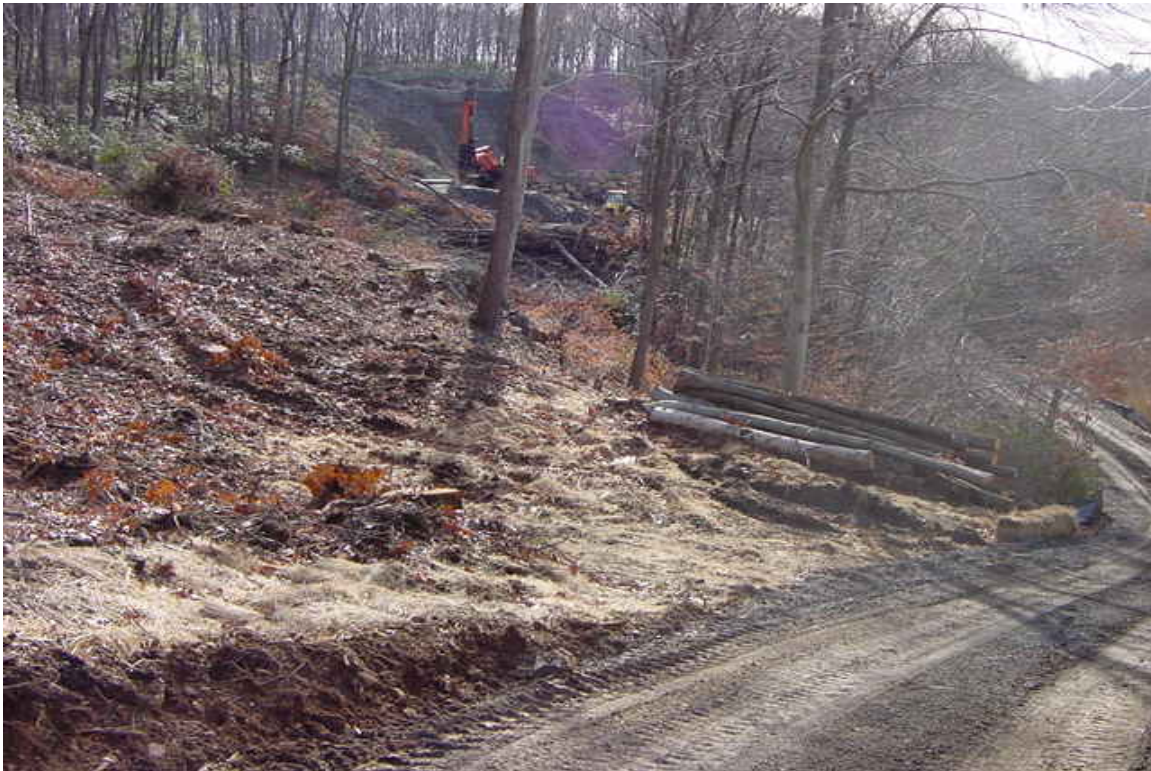
View of the cleared area at the Archers Lane/ROW edge, which has been stabilized with hay mulch.
12/01/05

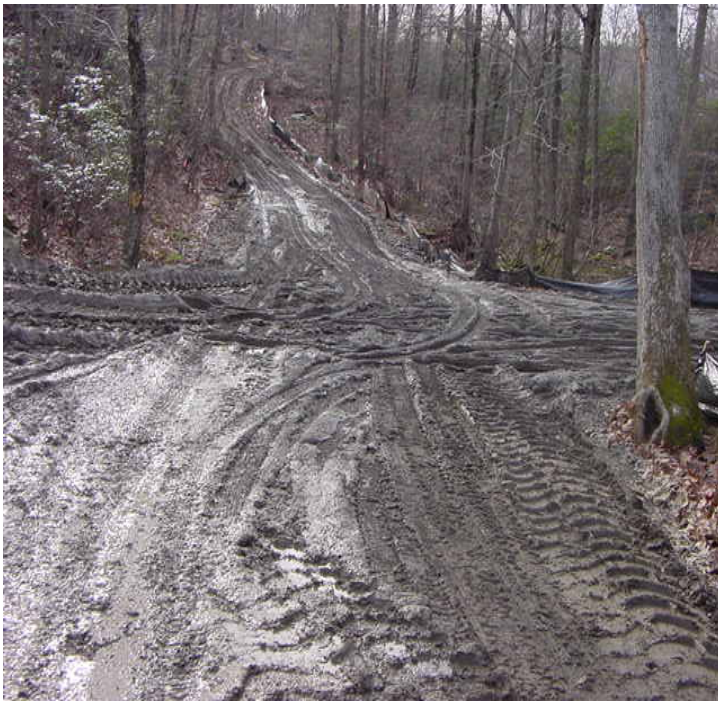
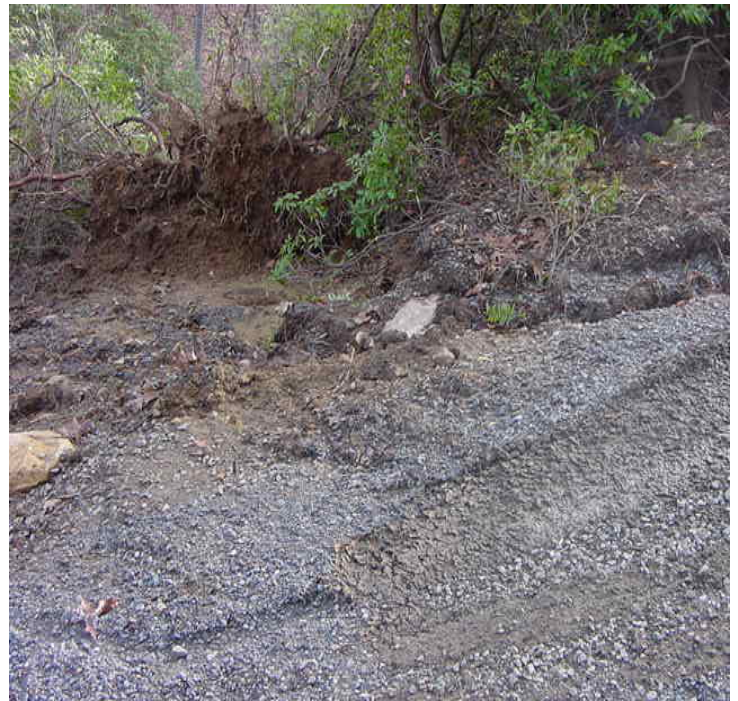
Photo on the left shows the muddy conditions on the access road causing some equipment to slip. Mats should be considered in these conditions. Photo on the right shows the disturbance created by a vehicle off the road. The area should be repaired and silt fence should be added here as stormwater appears to flow in that direction. 12/01/05.
